Walkability and Accessibility Audit: Case study of Mukuru Kwa Njenga Sustainable Transport Equity Partnerships (STEPS)

**Winnie V. Mitullah, Paschaline Basil,
Romanus O. Opiyo, Beatrice Hati, Modix
Okeyo**

University of Nairobi, Kenya

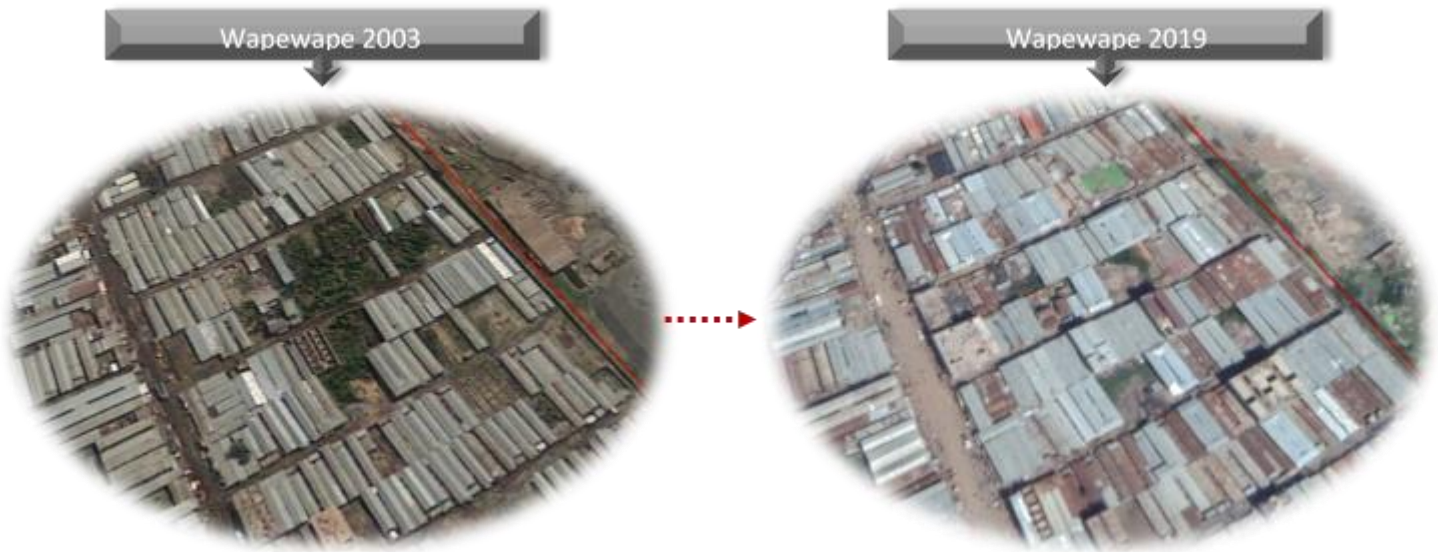
Picture 1- Spatial changes in Wapewape village

The rate of immigration into Mukuru Kwa Njenga with time was alarming and there was need to informally plan where each household would settle. The village elders were tasked with this responsibility and started informal subdivision and allocation of space to the residents. Due to the high demand and continual immigration they commercialized the process. Residents would offer some money to the elders for space allocation. This resulted in haphazard development with no consideration for accessibility. Space left for physical infrastructure was encroached and allocated to residents for commercial and residential development. The subsequent implication of this was narrow roads and dead ends within the settlement. The images on picture 1 illustrate the spatial changes that have taken place in a section of Wapewape Village in Mukuru Kwa Njenga between 2003 and 2019.

Local access routes were initially well demarcated (5-6m) but due to population pressure and demand for space, people have encroached into the road reserve and only left narrow routes which are barely accessible (1m). These trends have over time limited accessibility and circulation in Mukuru Kwa Njenga.

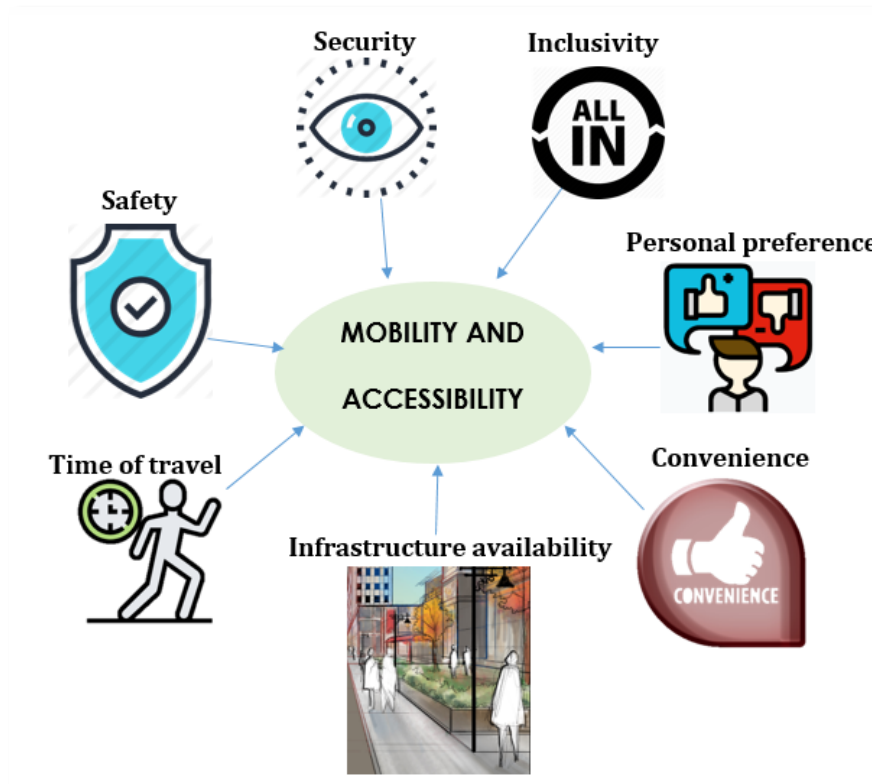
Figure 4- Parameters for the scoping study

These parameters enabled the researchers understand why pedestrians chose to use or avoid certain routes in the study area. This is based on the assumption that choice of a route is dependent on factors other than the availability of the route.

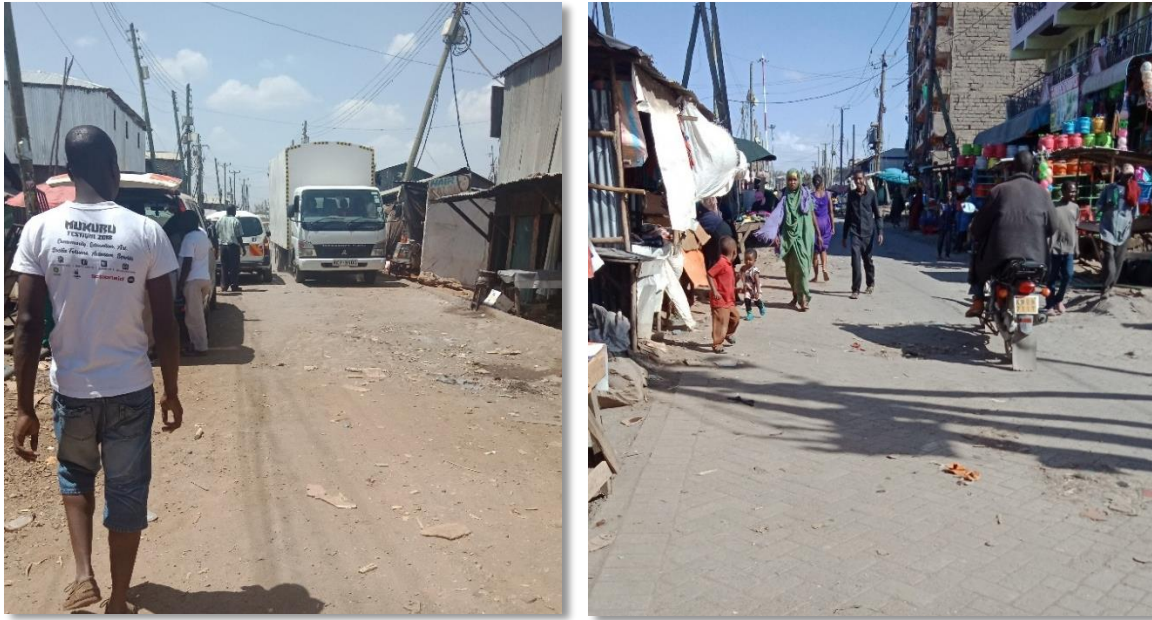
Picture 3- Pedestrians walking in Mukuru Kwa Njenga

Roads in the settlement are characterized by diverse forms of traffic. Major roads are comprised of both motorized and non-motorized traffic. The minor roads/local access routes are synonymous to non-motorized transport due to space limitation. Picture 3 below shows the various type of traffic observed on Mukuru roads and the general road use behaviors of the residents.

On most roads, pedestrian traffic is not segregated from vehicular traffic. Pedestrians often use the carriage way and have to pave way for vehicles and motorcycles. The interaction between pedestrians and vehicles is fairly safe as opposed to the interaction with motorcycles. Despite the narrow and congested state of the roads, motorcycles are always driven recklessly and at very high speed. The residents interviewed during the survey cited motorcycles as a key threat to mobility on Mukuru roads.

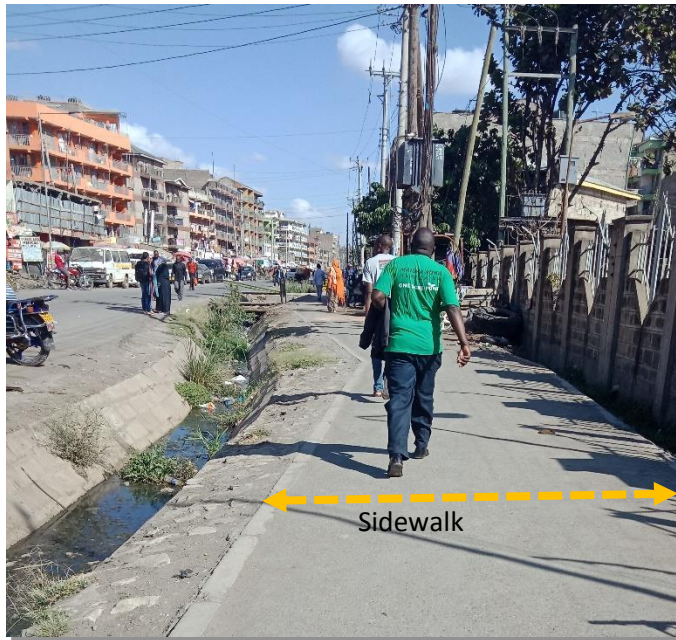
Picture 4- Designated footpath on Catherine Ndereba road

Picture 4 portrays the layout and use of Catherine Ndereba road; recently upgraded by the Nairobi City County Government. Pedestrians along this route stated that over the years they had been used to walking on the carriageway and have not yet adjusted to the planned mobility route.

Some sections of the route are either partially or completely encroached by informal businesses leaving pedestrians no choice but to use the carriageway.

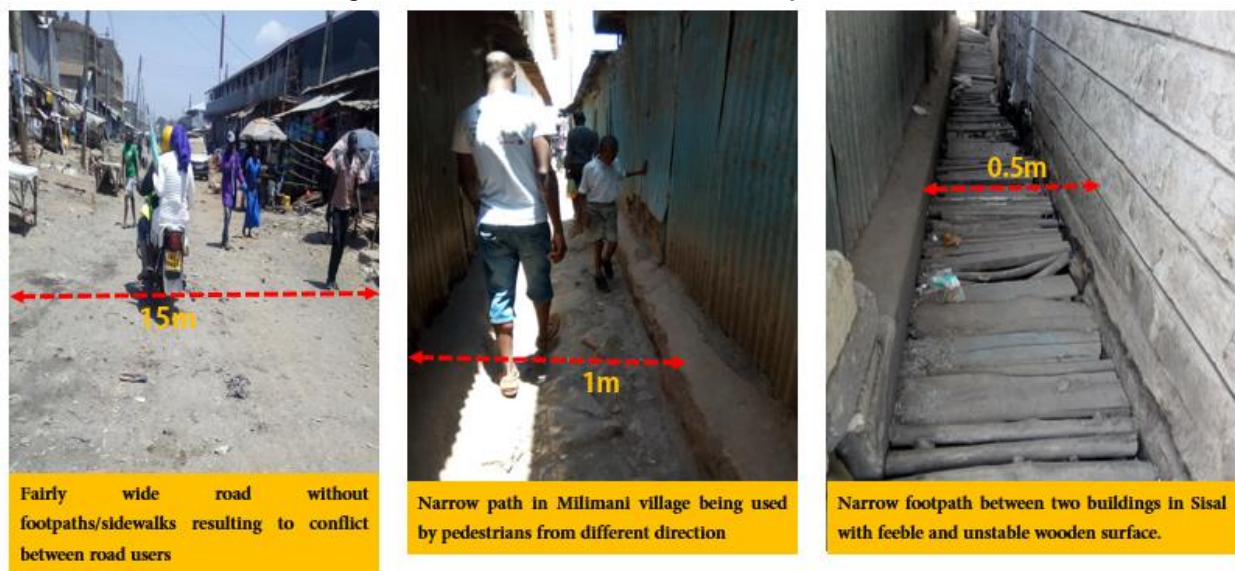
Figure 8: Minimum and maximum road/path width

Comparing the existing widths of streets and pedestrian walks and paths in Mukuru against the ideal situation, it is evident that there is need for provision of adequate pedestrian widths to enable easy and safer movement of pedestrians. Footpaths and sidewalks should be wide enough to allow two adults to walk comfortably next to each other. The width of a footpath can vary as per the adjacent land use. Footpaths in residential areas require a minimum clear width of 1.8 m, which is enough space for two wheelchairs to pass each other. For commercial areas, the clear width should be at least 2.5 m (Institute for Transportation and Development Policy, 2013).

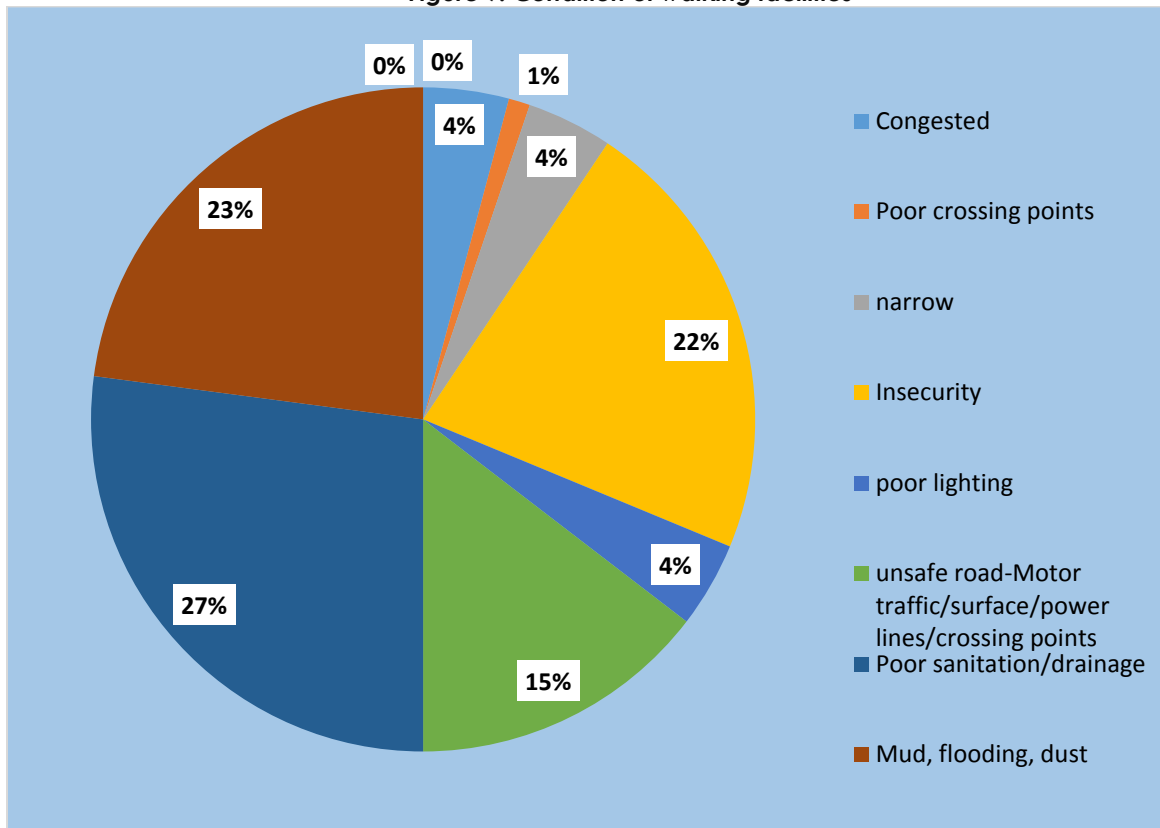
Figure 9: Condition of walking facilities

Condition of pedestrian infrastructure plays a critical role in enhancing walkability within streets. The walkability audit conducted in Mukuru Kwa Njenga, found out that the general condition of sidewalks and pedestrian paths is pathetic and unreliable. According to 27% of respondents drainage systems are poor, 23% are affected by adverse weather making them either muddy or flooded during rain and dusty during dry, windy season. As many as 23% of the residents believe that the paths are insecure, 16% consider them unsafe for walking by children, women, the aged and PWDs. The paths according to 4 percent of respondents are congested during peak hours; are too narrow to accommodate two people at a time (4%) and also lacks proper lighting (4%) as shown on figure 9.

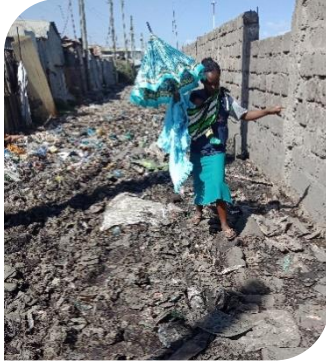
On our second day of the survey we meet 'Nancy'. She has a child on her back and is struggling to pass over solid waste dumped on the footpath. The situation has been worsened by a clogged open sewer. She struggles to step on stones that have been placed to help pedestrians maneuver over the sewer and solid waste. This is very unsafe for her and other pedestrians and she suggests that footpaths cannot be termed as walkable if they do not have efficient drainage and sewer systems. She also states that in order to create

proper footpaths, solid waste management should be prioritized.
